**US Army Corps
of Engineers®**
Engineer Research and
Development Center

Feasibility Investigation into Strengthening of Timber Bridge Stringers

Final report

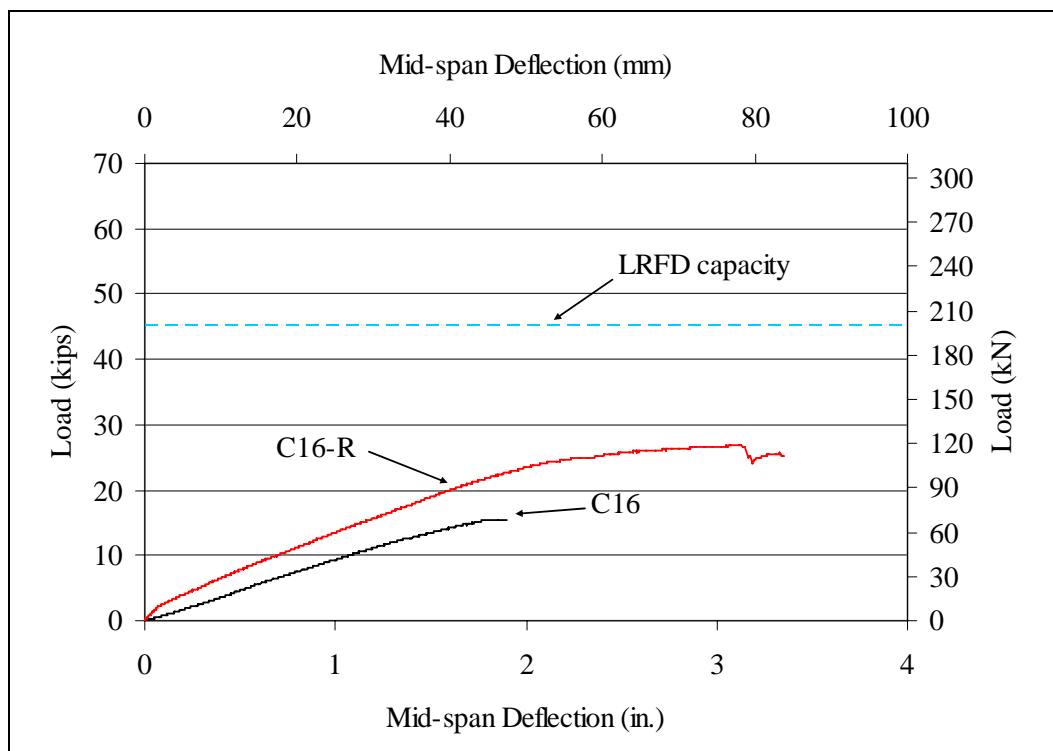
The load-deflection curve for stringer C16-R, shown in Figure 113, was up to a load of 111 kN (25 kips). The stringer developed tension cracks and splinters within the tension zone at failure. The repaired ultimate load was 120 kN (27 kips) at a displacement of 80 mm (3.15 in.). Horizontal sliding occurred at the support faces as the load approached failure. There was no visible damage on the FRP side plates, except for minor local buckling problems.

Figure 113. Load-deflection curves for stringers C16 and C16-R.

Timber stringer C16-R had existing end splitting before testing, and it was repaired using FRP side plates. The increase in the repaired ultimate load over the unstrengthened postfailure capacity was 80%, and a higher stiffness was provided by the repair, as shown in Figure 113. The FRP plates provided higher increase in the repaired ultimate load and stiffness. Therefore, it was feasible to use FRP side plates to enhance the load behavior of the timber stringers with end splitting when compared with repairing with hex bolts or lag screws. The FRP side plates also did not develop major damage except minor bearing damage where lag screws were installed.

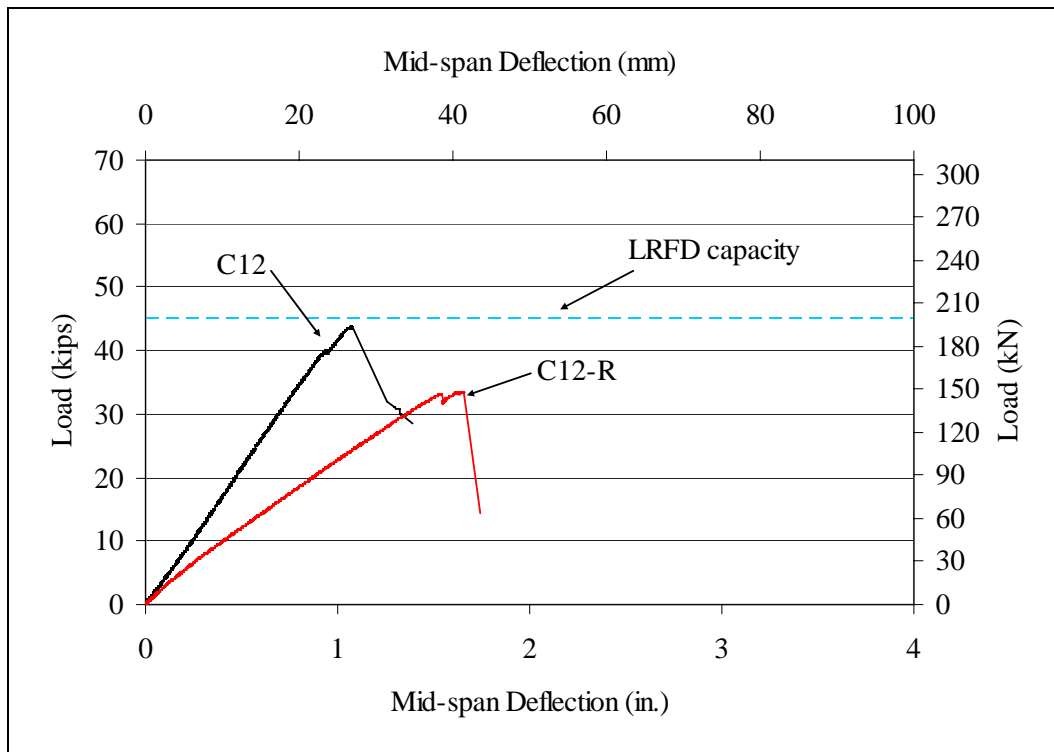
Stringer C12-R had an FRP strip attached to the tension zone using lag screws. Flexural reinforcement was used along with the lag screws because stringer C12 developed a cross-grain tension failure. The increase in the repaired ultimate load over the unstrengthened postfailure capacity for the repaired stringer was 17.2%. The original and repaired ultimate loads were 196 kN (44 kips) and 151 kN (34 kips) for stringers C12 and C12-R, respectively. This represents a 77% recovery in the ultimate load of stringer C12-R. The stiffness of the timber stringer was lower than that of stringer C12-R, as seen Figure 114. The repaired stringer had a horizontal

Figure 114. Load-deflection curves for stringers C12 and C12-R.

The load-deflection curve for stringer C12-R, shown in Figure 111, was linear until a small drop occurred in the load carrying capacity at 147 kN (33 kips). There were no visible cracks at this point. The load increased further until the stringer failed in horizontal shear, causing a drop in the load carrying capacity. The repaired ultimate load was 151 kN (34 kips) at a displacement of 42 mm (1.66 in.).

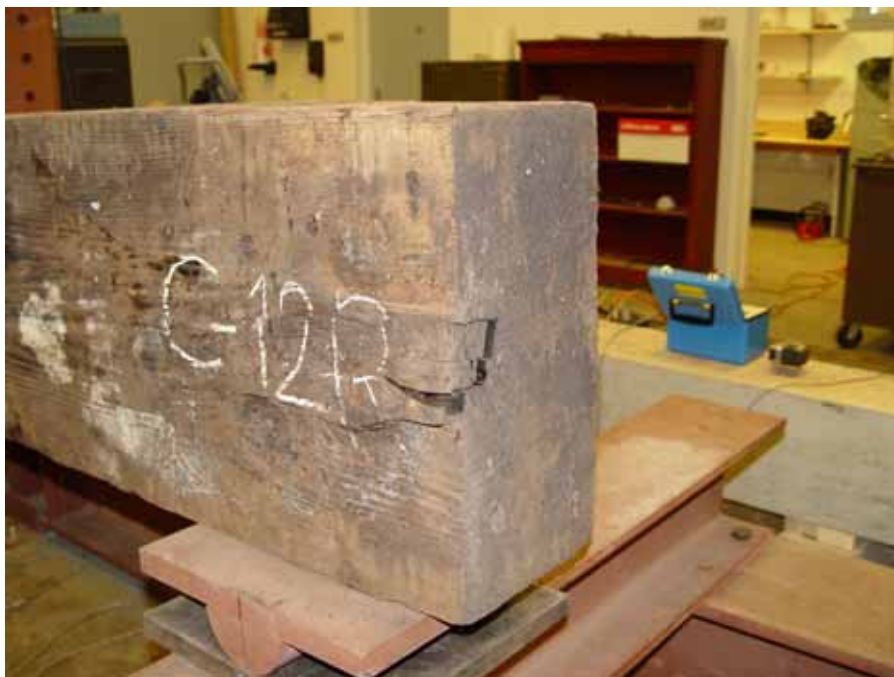
shear crack at failure. However, the horizontal shear failure was not entirely across the width of the cross section, as shown in Figure 115.

Figure 115. Horizontal shear crack after the failure of stringer C12-R.

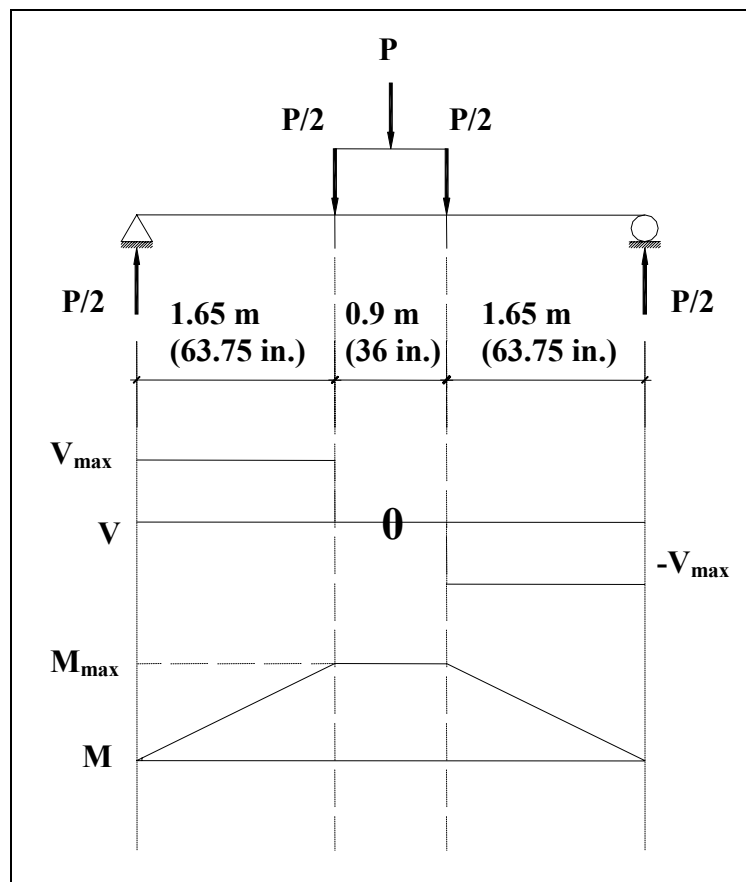
All stringers that were tested on a span of 4.2 m (13.6 ft) with 2 equal loads applied symmetrically at a distance of 457 mm (18 in.) from the centerline, to create a zone of constant moment (M) and shear (V) in the stringer, as shown in Figure A1. The maximum shear was equal to one-half of the applied load along the shear span. Shear forces in the stringer under the spreader beam had a value of zero. Bending moment, however, was a constant and maximum along the spreader beam.

Figure A1. Moment and shear diagrams for timber stringers.

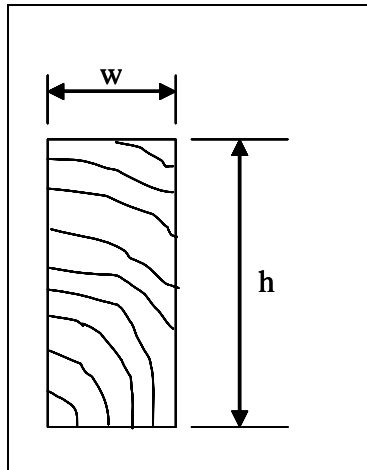
Width (w) and height (h) of the tested timber stringers were 191 mm (7.5 in.) and 406 mm (16 in.) respectively, as shown in Figure A2. Area of the stringers was 775.46 cm² (120 in.²).

Figure A2. Schematic of cross section of a timber stringer.

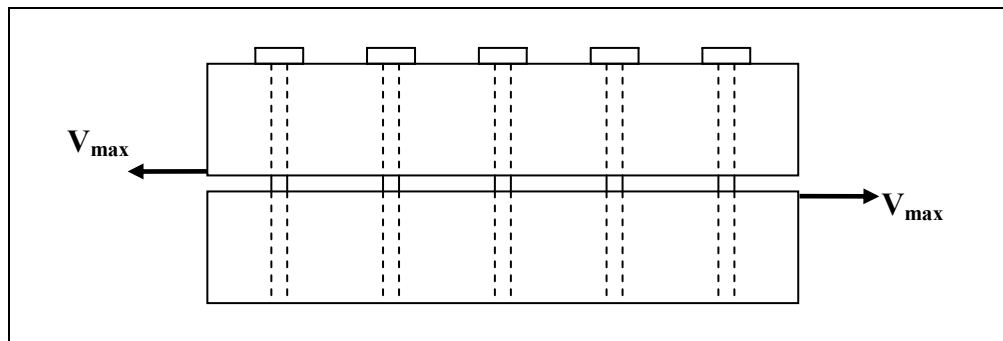
AFPA (1996) mechanical connection concepts were used to calculate the required number of hex bolts and lag screws. A complete separation was assumed at the neutral plane, over the entire length of the stringers. The required number of hex bolts and lag screws were computed by modeling this system as a single shear connection, as shown in Figure B1.

Figure B1. Single shear connection model for hex bolts and lag screws.

The purpose of the hex bolts and lag screws were to transfer the shear stresses along the length of the stringers. The reference lateral resistance of one hex bolt and lag screw was determined using Section 7.5 of AFPA (1996). For single shear connection Section 7.5 provides six different failure modes for hex bolts and three failure modes for lag screws. Among the failure modes which gave the smallest value controlled the capacity of the shear connection.

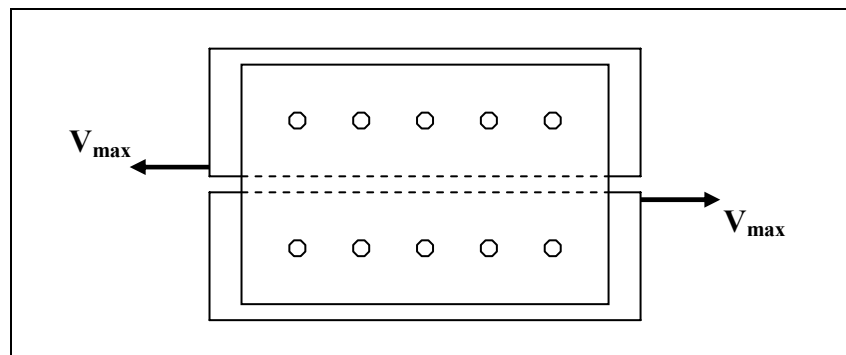
AFPA (1996) mechanical connection concepts were utilized to find out the required number of lag screws to attach side plates. A complete separation along the entire length of the stringers was assumed at the neutral plane as in previous section. The required number of lag screws was computed by modeling this system as single shear connection, as shown in Figure C1.

Figure C1. Single shear connection model for side plates attached using lag screws.

The purpose of the lag screws and side plates was to transfer the shear stresses along the length of the stringers. In the calculations bearing capacity of the side plates and timber beam was assumed to be equal. Side plates was also not used over the entire length of the timber stringers to prevent buckling problem due to bending of plates. Reference lateral resistance of one lag screw was determined using Section 7.5 of AFPA (1996). Section 7.5 provides three failure modes for lag screws for single shear connection. Among the failure modes the one which gave the smallest value controlled the capacity of the shear connection.
